The Road Inventory of Tallahatchie National Wildlife Refuge

Grenada, MS

Prepared By: Federal Highway Administration Central Federal Lands Highway Division November, 2011

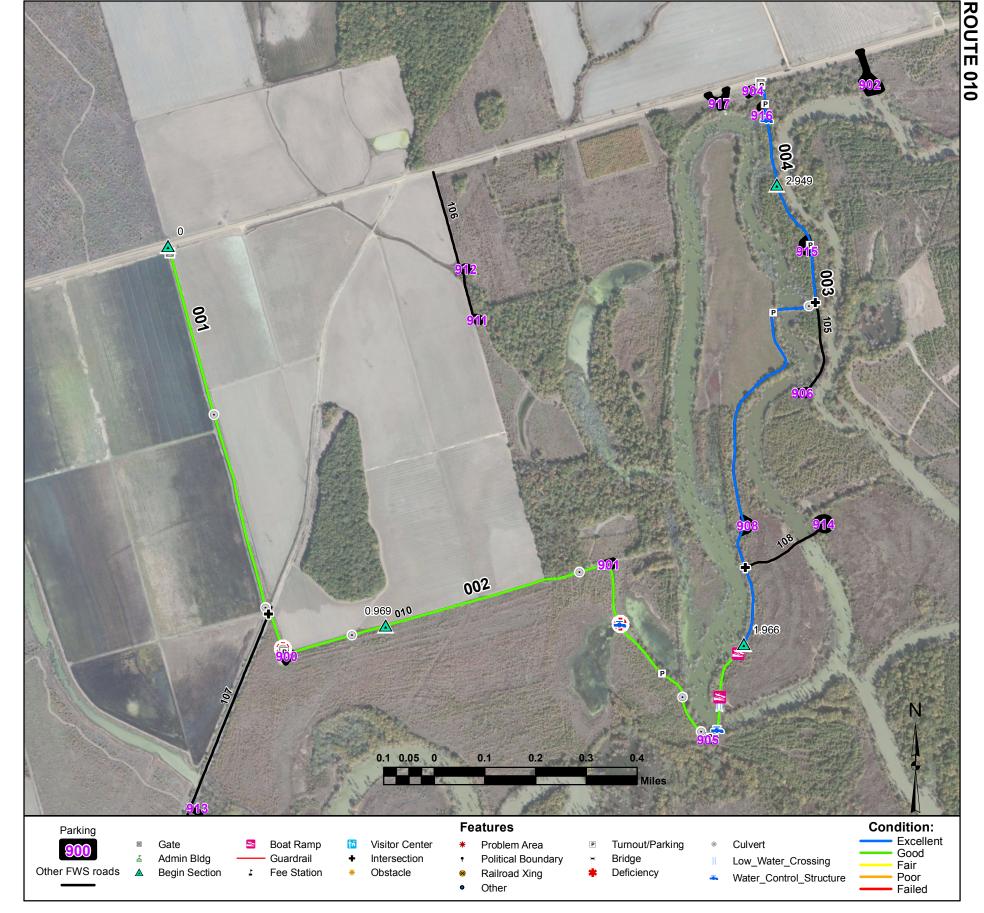
Horse Barn Loop

Asset Number	10044520	10044520	10044520	10044520
Section Number	001	002	003	004
Section Length (miles)	0.97	1.00	0.98	0.20
Inspection Date	05-18-2011	05-18-2011	05-18-2011	05-18-2011
Surface Type	Gravel	Gravel	Gravel	Gravel
Number of Lanes	1	1	1	1
Roadway Width (feet)	14	12	14	14
Condition	Good	Good	Excellent	Excellent
Remaining Service Life (years)	7	7	8	8
Estimated Cost to Repair	\$1,400	\$1,400	\$0	\$0
Current Replacement Value	\$598,300	\$615,300	\$607,100	\$120,700

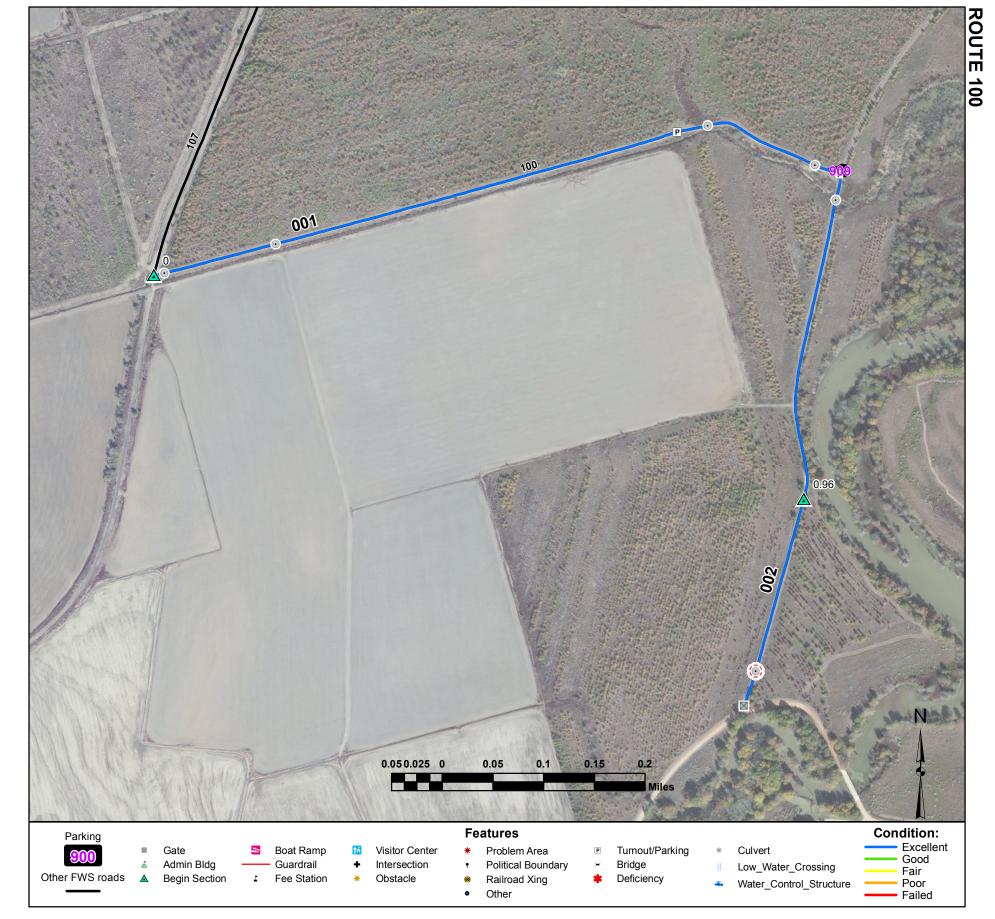
South Entrance Road

Asset Number Section Number Section Length (miles)	10044517 001 0.96	10044517 002 0.20		
Inspection Date	05-18-2011	05-18-2011		
Surface Type Number of Lanes	Gravel	Gravel		
Roadway Width (feet)	12	12		
Condition	Excellent	Excellent		
Remaining Service Life (years)	8	8		
Estimated Cost to Repair	\$0	\$0		
Current Replacement Value	\$592,600	\$121,700

Features	Mile Post	Features	Mile Post	Features	Mile Post	Features	Mile Post
Begin Section	001-0.0						
Culvert	001-0.01						
Culvert	001-0.12						
Turnout/Parking	001-0.52						
Culvert	001-0.55						
Culvert	001-0.66						
Turnout/Parking	001-0.68						
Culvert	001-0.71						
Begin Section	002-0.96						
Culvert	002-1.12						
Deficiency Culvert	002-1.12						
Gate	002-1.16

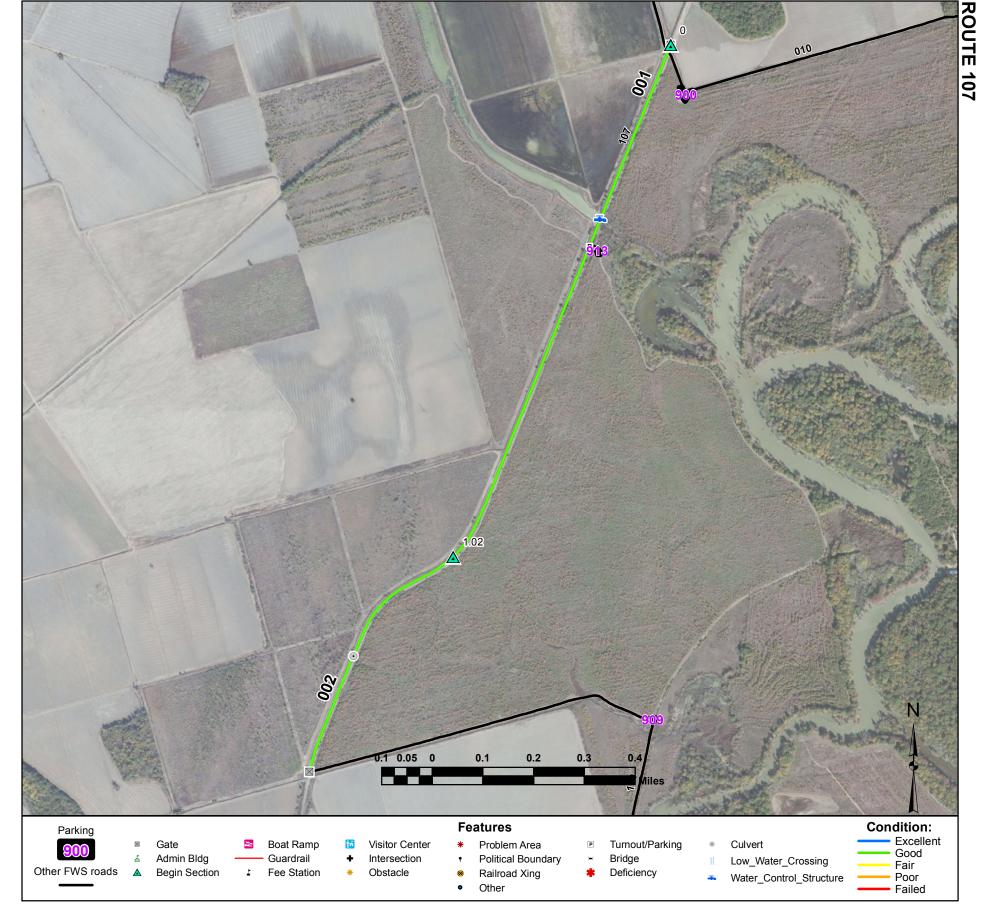
Dummy Line Road

Asset Number Section Number Section Length (miles)	10044517 001 1.02	10044517 002 0.49		
Inspection Date Surface Type	05-18-2011 Gravel	05-18-2011 Gravel		
Number of Lanes Roadway Width (feet)	1 1	1 14		
Condition	Good	Good		
Remaining Service Life (years) Estimated Cost to Repair Current Replacement Value	7 \$1,500 \$630,000	7 \$700 \$304,500

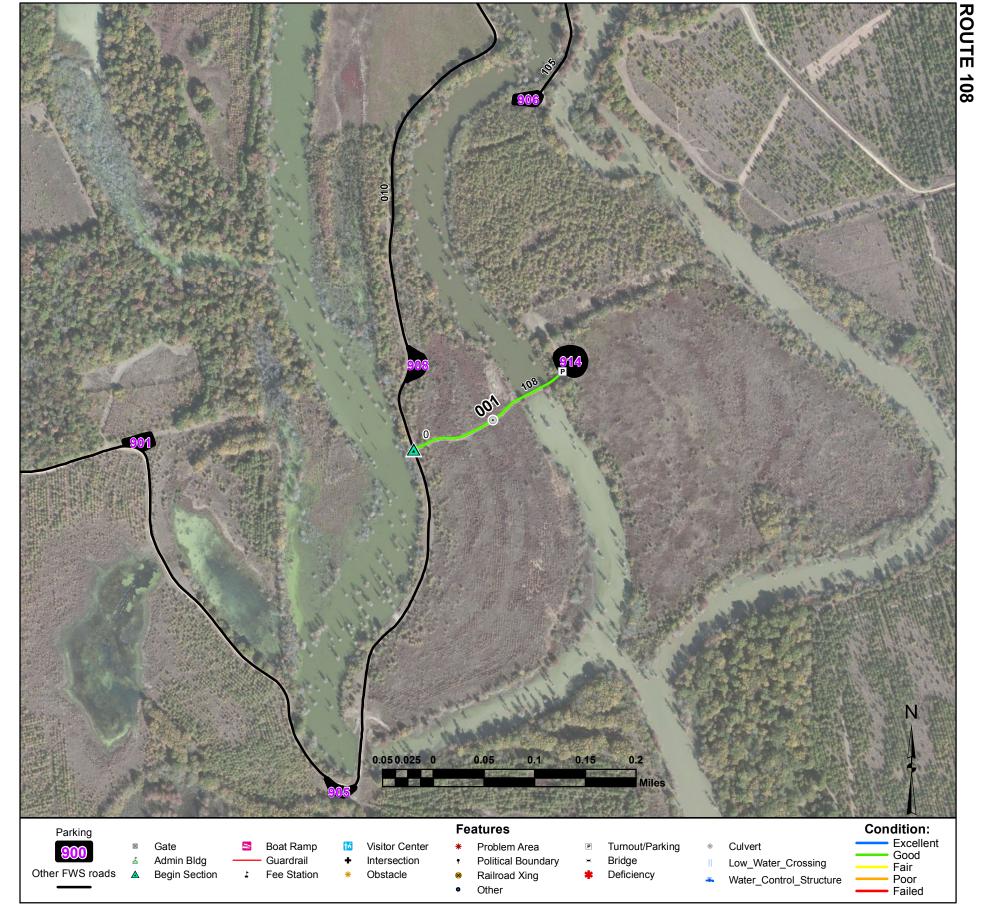
Cypress Road

Asset Number	-
Section Number	001
Section Length (miles)	0.16
Inspection Date	05-18-2011
Surface Type	Gravel
Number of Lanes	1
Roadway Width (feet)	10
Condition	Good
Remaining Service Life (years)	7
Estimated Cost to Repair	\$200
Current Replacement Value	\$96,700

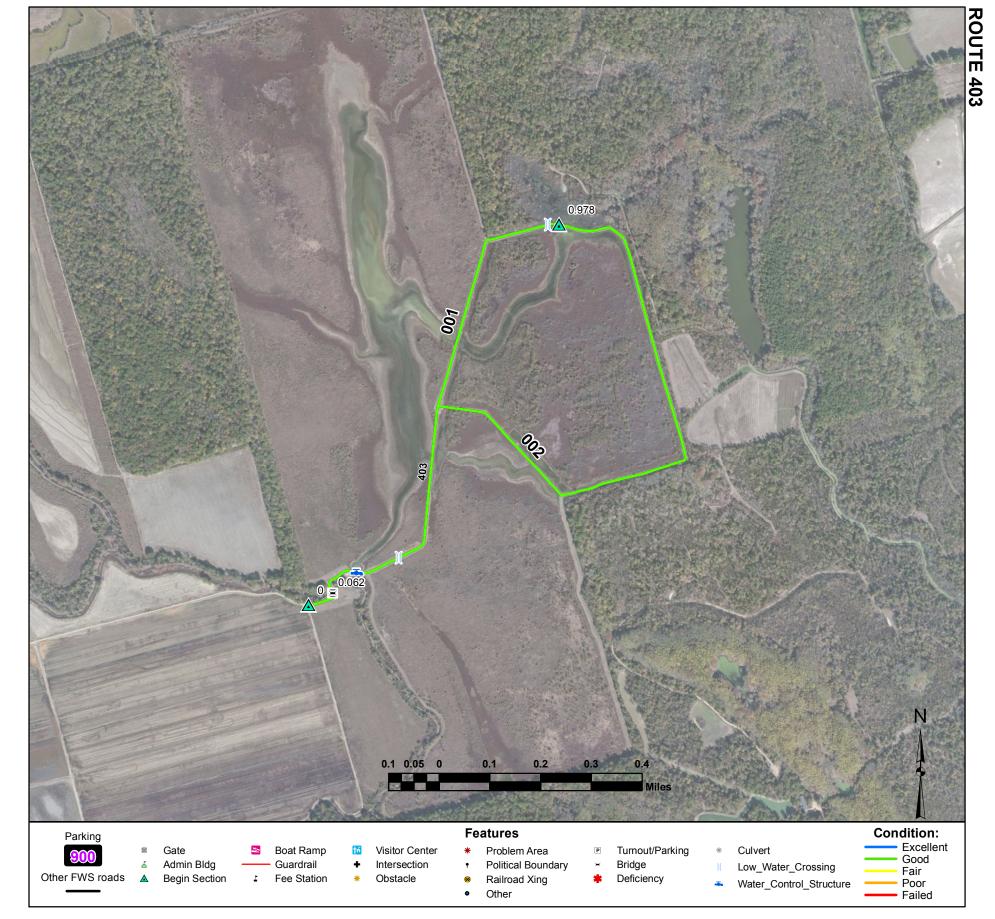
Walker Tract Access Road

Asset Number	10056984	10056984	
Section Number	001	002	
Section Length (miles)	0.98	1.08	
Inspection Date	05-18-2011	05-18-2011	
Surface Type	Gravel	Gravel	
Number of Lanes	1	1	
Roadway Width (feet)	10	10	
Condition	Good	Good	
Remaining Service Life (years)	7	7	
Estimated Cost to Repair	\$1,400	\$1,600	
Current Replacement Value	\$604,100	\$664,800

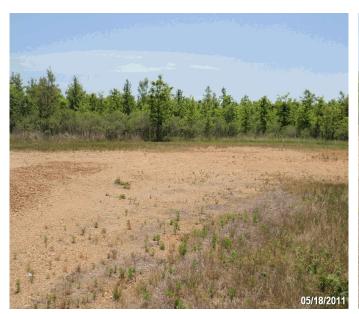
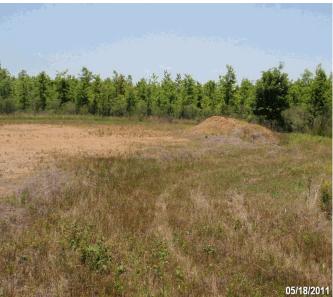
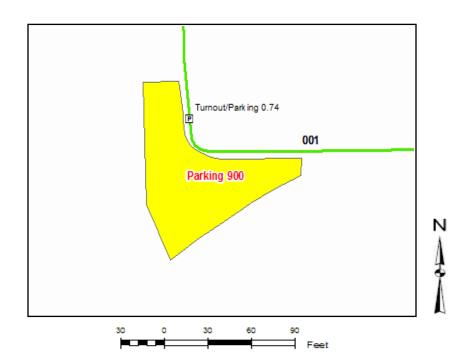
Asset Number	Date Visited	Surface Type	Area (Sq Ft)	Condition	Cost to Improve
10044522	05/18/2011	Gravel	7,061	Fair	1,700

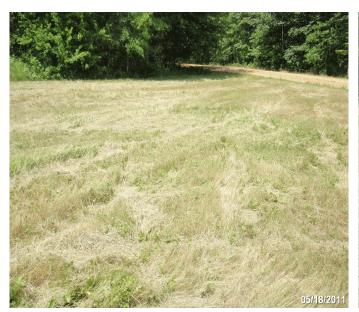
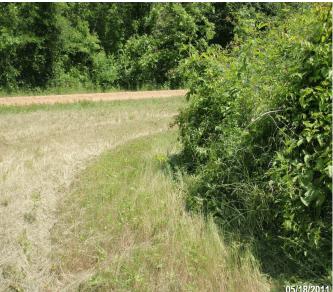
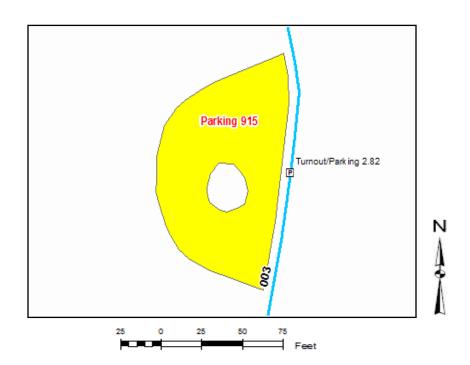
A	Data	Conford	A		0
Asset Number	Date Visited	Surface Type	Area (Sq Ft)	Condition	Cost to Improve
	05/18/2011	Native	9,425	Fair	2,200
